**SAS Superstructure**

**Daily Diary Report by Bid Item**

Contract No.: 04-0120F4

Diary #: 195 Const Calendar Day: 834 Date: 21-Dec-2011 Wednesday

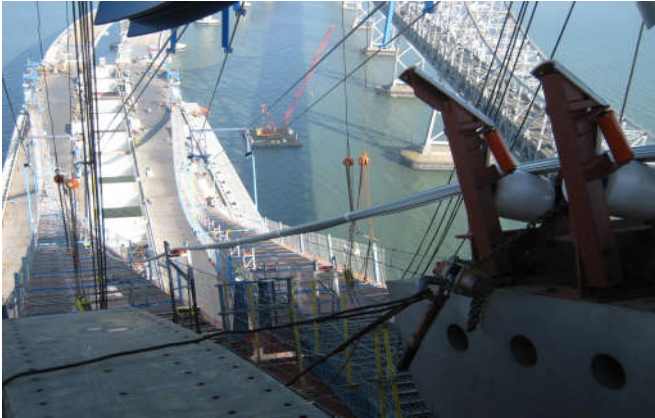
- From 12:30 until 13:30, the upper roller on the main span catwalk was raised to help support the strand and relieve some of the stress from the roller on the Tower saddle that was getting damaged (see attached photo).

Modified condition (after raising top roller) of strand support at the top of the North main span catwalk

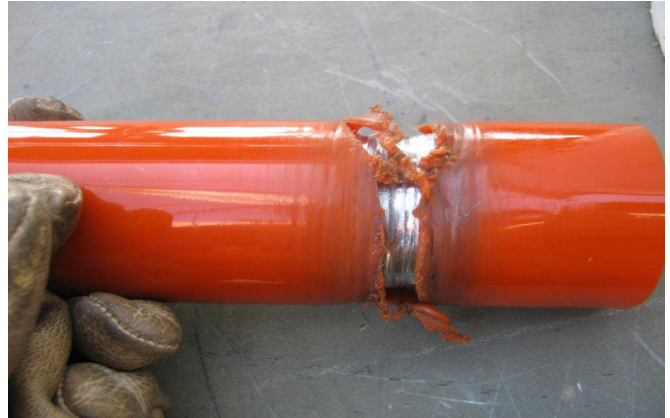
- At 10:20, the rubber coating on the roller adjacent to the main span was worn completely through, and the strand was rolling on the galvanized roller under the rubber sleeve. At this point, they again stopped the hauling.

- At 10:25, the hauling was re-started.
- After a little while, the galvanizing on the roller also started to show signs of damage (see attached photo), so the hauling was paused, and they floated the strand with chainfalls and the side roller was replaced. This happened 2 more times during the hauling along the primary haul system. They changed out a total of 3 rollers.

Damaged roller

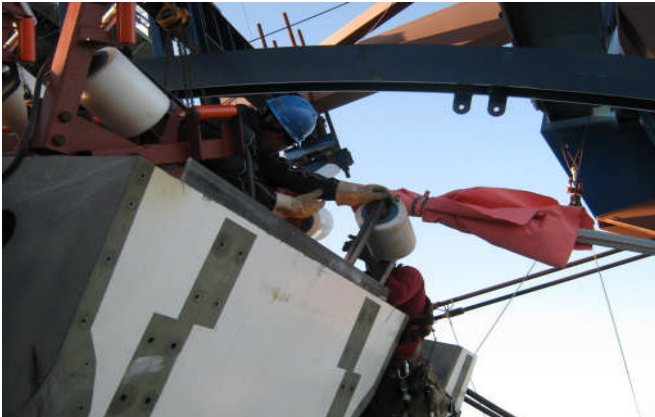
Installing additional roller on Tower saddle adjacent to North main span catwalk

- From 13:30 until 15:30, the strand was being pulled slowly around the West loop. No additional damage to roller was noticed during this time. During this time, the crew at the Tower saddle was fabricating some brackets for an additional roller to install adjacent to the North main span. This roller was installed at 15:45.

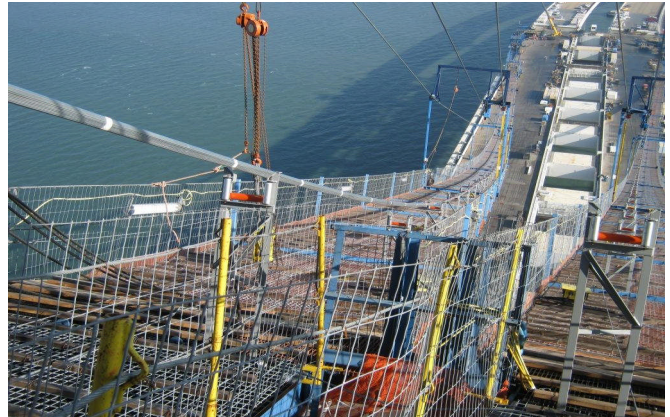
- At 10:10, the hauling was re-started. The strand at the top of the main span was not supported by the top 3 rollers (see attached photo). This was putting extra load on the 1st roller adjacent to the main span, and the rubber coating on the side roller started to wear.

Initial condition of strand support at the top of the North main span catwalk
